New Hampshire Volunteer Lake Assessment Program

2002 Bi-Annual Report for Halfmoon Pond Washington

Halfmoon Pond, Washington

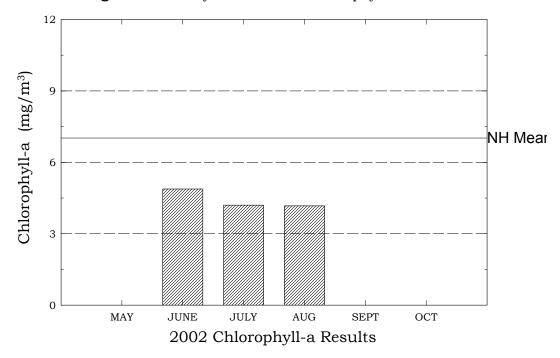
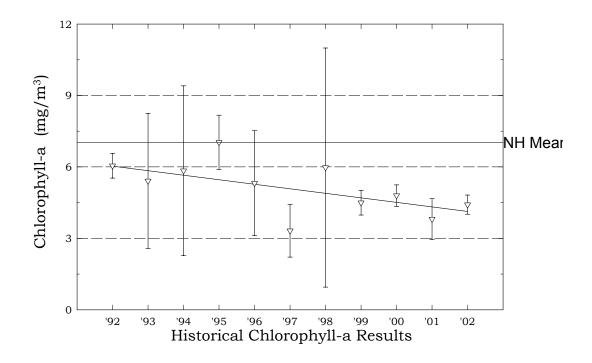
Figure 1. Monthly and Historical Chlorophyll-a Results

Figure 1 and Table 1: The graphs in Figure 1 (Appendix A) show the historical and current year chlorophyll-a concentration in the water column. Table 1 (Appendix B) lists the maximum, minimum, and mean concentration for each sampling season that the lake/pond has been monitored through the program.

The current year data (the top graph) show that the chlorophyll-a concentration *decreased slightly* from June to July, and then *remained stable* from July to August.

The historical data (the bottom graph) show that the 2002 chlorophyll-a mean is *less than* the state mean.

Overall, the statistical analysis of the historical data show that the chlorophyll-a concentration has **significantly decreased** since monitoring began. Specifically, the chlorophyll-a concentration has **decreased** (meaning **improved**) on average **by approximately 3.9 percent** per sampling season during the sampling period **1992** to **2002**. (Note: Please refer to Appendix E for the detailed statistical analysis explanation and data print out.) We hope this trend continues!

While algae are naturally present in all lakes/ponds, an excessive or increasing amount of any type is not welcomed. In freshwater lakes/ponds, phosphorus is the nutrient that algae depend upon for growth. Therefore, algal concentrations may increase when there is an increase in nonpoint sources of nutrient loading from the watershed, or in-lake sources of phosphorus loading (such as phosphorus releases from the sediments). It is important to continually educate residents about how activities within the watershed can affect phosphorus loading and lake quality.

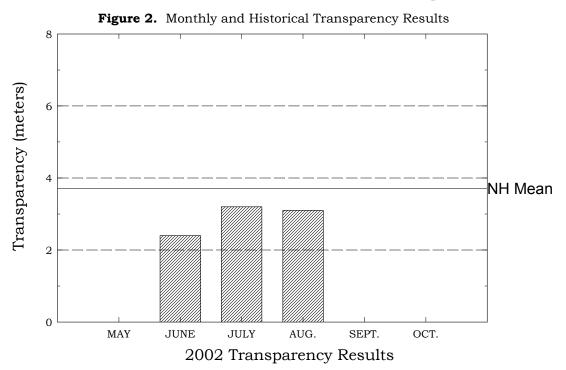
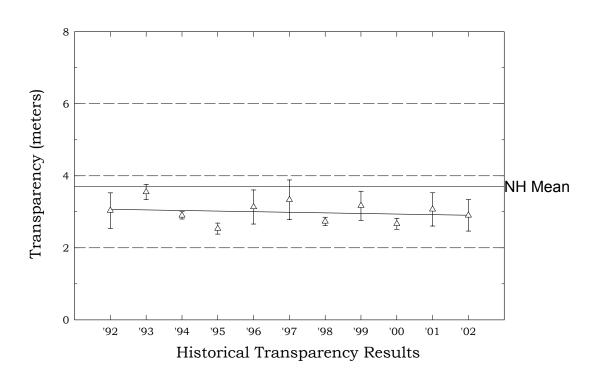
Figure 2 and Table 3: The graphs in Figure 2 (Appendix A) show historical and current year data for lake/pond transparency. Table 3 lists the maximum, minimum and mean transparency data for each sampling season that the lake/pond has been monitored through the program.

The current year data (the top graph) show that the in-lake transparency *increased* from June to July, and then *remained stable* from July to August.

The historical data (the bottom graph) show that the 2002 mean transparency is **slightly less than** the state mean.

Overall, the statistical analysis of the historical data (the bottom graph) show that the mean annual in-lake transparency has **not significantly changed** (either *increased* or *decreased*) since monitoring began in **1992**. Specifically, the in-lake transparency has been **very stable** and **slightly less than** the state mean. (Note: Please refer to Appendix E for the statistical analysis explanation and data print out.)

Typically, high intensity rainfall causes erosion of sediments into lakes/ponds and streams, thus decreasing clarity. Efforts should continually be made to stabilize stream banks, lake/pond shorelines, disturbed soils within the watershed, and especially dirt roads located immediately adjacent to the edge of tributaries and the lake/pond. Guides to Best Management Practices designed to reduce, and possibly even eliminate, nonpoint source pollutants, such as sediment loading, are available from NHDES upon request.

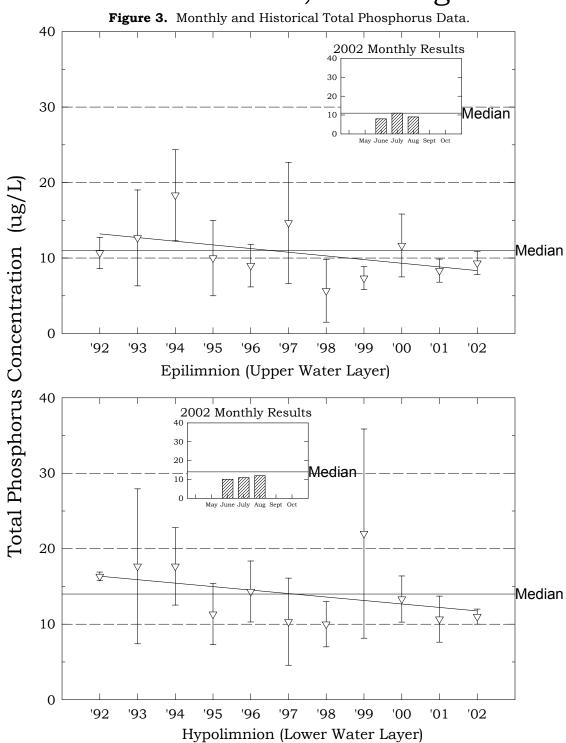
Figure 3 and Table 8: The graphs in Figure 3 (Appendix A) show the amounts of phosphorus in the epilimnion (the upper layer) and the hypolimnion (the lower layer); the inset graphs show current year data. Table 8 (Appendix B) lists the annual maximum, minimum, and median concentration for each deep spot layer and each tributary since the lake/pond has joined the program.

The current year data for the epilimnion (the top inset graph) show that the total phosphorus concentration *increased slightly* from June to July, and then *decreased slightly* from July to August.

The historical data show that the 2002 mean epilimnetic total phosphorus concentration is **slightly less than** the state median.

The current year data for the hypolimnion (the bottom inset graph) show that the total phosphorus concentration **increased very gradually** from June to August.

The historical data show that the 2002 mean hypolimnetic total phosphorus concentration is *less than* the state median.

Overall, the statistical analysis of the historical data show that the total phosphorus concentration in the epilimnion (upper layer) and the hypolimnion (lower layer) has **not significantly changed** (either increased or decreased) since monitoring began in **1992.** Specifically, the total phosphorus concentration in the epilimnion and hypolimnion has **varied** (meaning **fluctuated**) but has not continually increased or decreased since monitoring began. (Note: Please refer to Appendix E for the statistical analysis explanation and data print out.)

One of the most important approaches to reducing phosphorus loading to a waterbody is to continually educate watershed residents about its sources and how excessive amounts can adversely impact the ecology and value of lakes and ponds. Phosphorus sources within a lake or pond's watershed typically include septic systems, animal waste, lawn fertilizer, road and construction erosion, and natural wetlands. If you would like to educate watershed residents about how they can help to reduce phosphorus loading into the lake/pond, please contact the VLAP Coordinator.
